SCOUR EVALUATION FOR THE NILE RIVER BENDS ON ROSETTA BRANCH**ABSTRACT**

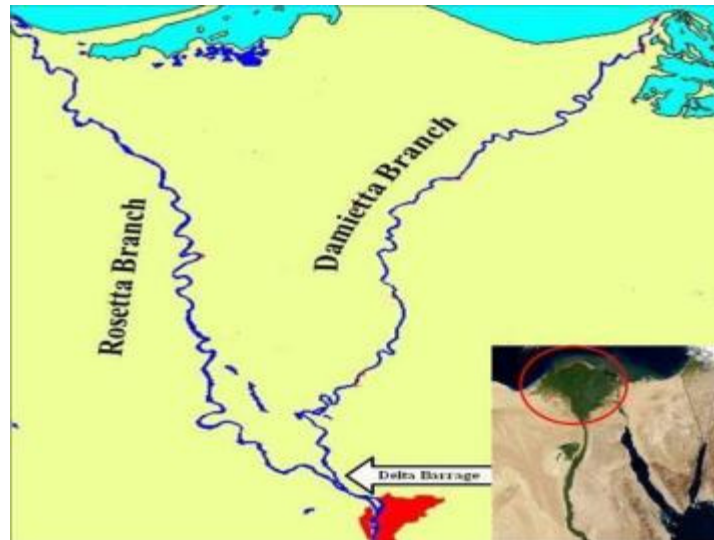
Fig. 1. Rosetta and Damietta Branches

The average bed slope along the Damietta and Rosetta Branches of the Nile Delta (240km from Delta Barrage, Fig. (1) was 5.6cm/km. The suspended bed material loads for the Nile downstream Aswan has changed substantially as a result of the creation of Lake Nasser, HRI [1].

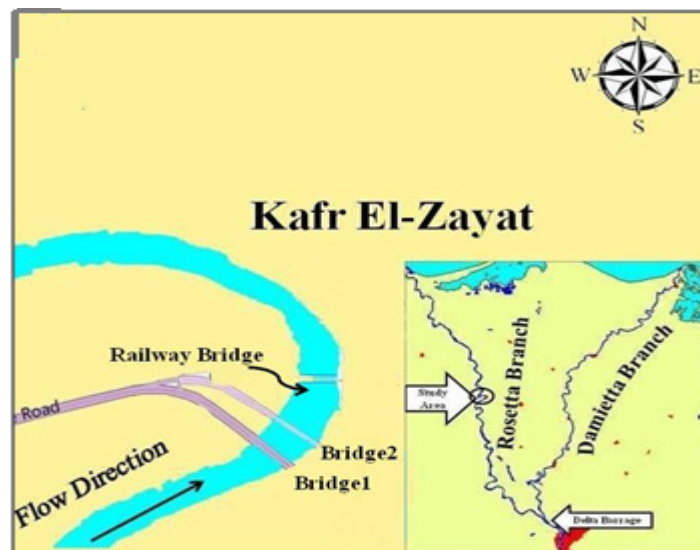
Fig. 2. Location of the Study Reach**Table 1.:** Location and Dimensions of the Bridge Piers

Kafr El-Zayat City is located at the outer curve of a very sharp bend at Km 123 of Rosetta Branch. The study area was 3.5km long, located downstream of Delta Barrage from km 145.00 to km 148.50 downstream of El-Roda Gauge Station. The study area is a bend consisting two highway bridges and one railway bridge were located. Fig. (2) and Table (1) show the geometry and location of the 13 bridge piers and their distance from the left bank.

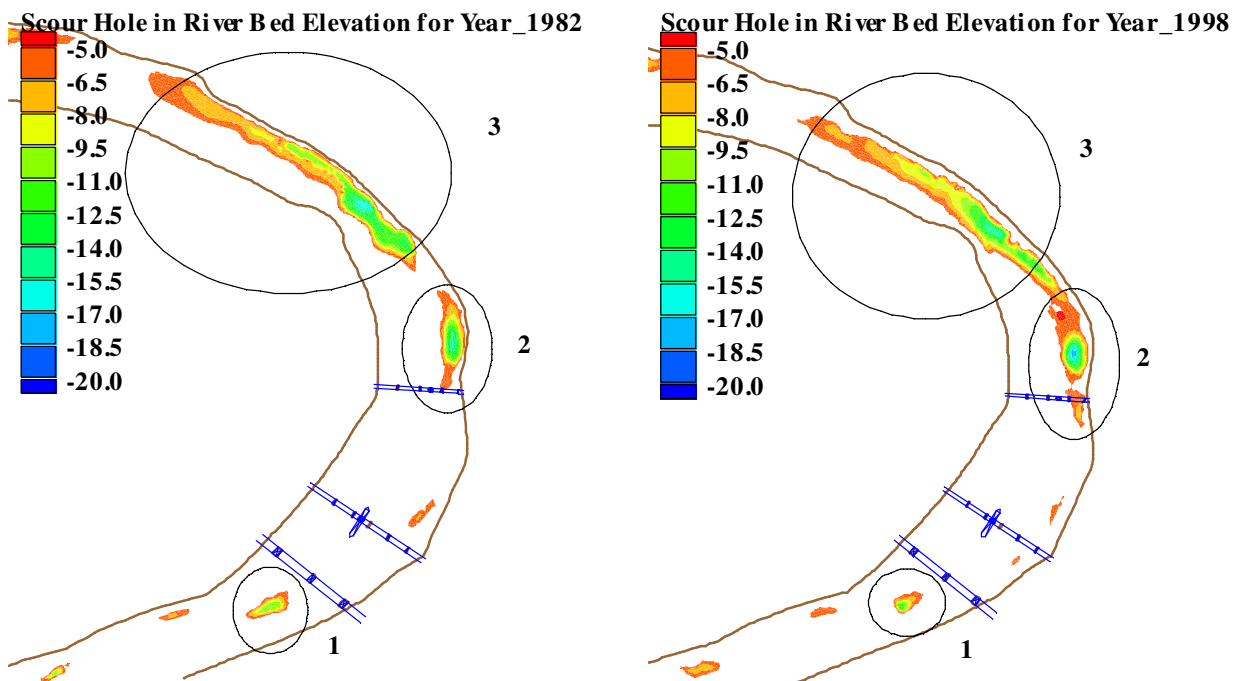
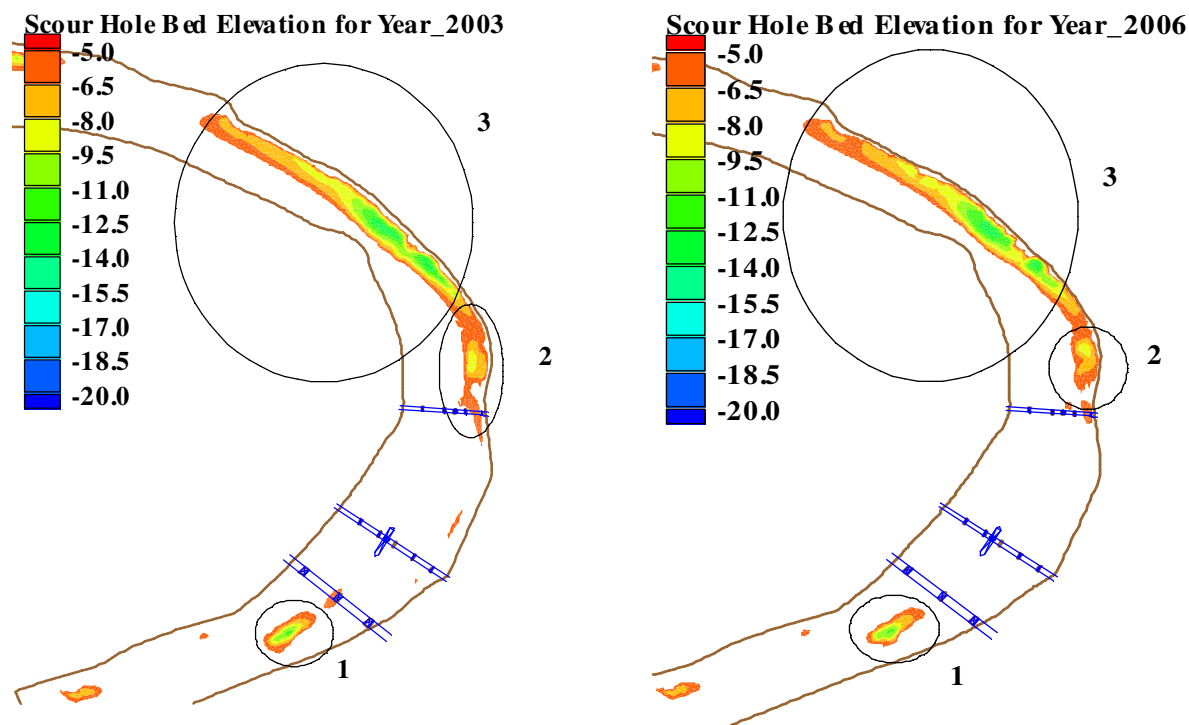
Fig. 9. Scour Holes Location in Study Area at Years 1982, 1998, 2003 & 2006

Fig. (9) showed the location and the geometry development of the scour holes in the studied area from years 1982 to 2006. In the outer curve, the velocity was higher than inner curve. Consequently, the scour holes were located at the outer curve of the meander which in turn exposes it to the risk of failure. From figure investigations it's dedicated that the area of scour holes No.1 were wider in year 2006 than year 1982, however the scour holes No.2 &3 were deposited in the same time period. The output findings were found to be match with the results obtained by Chang H., [9].

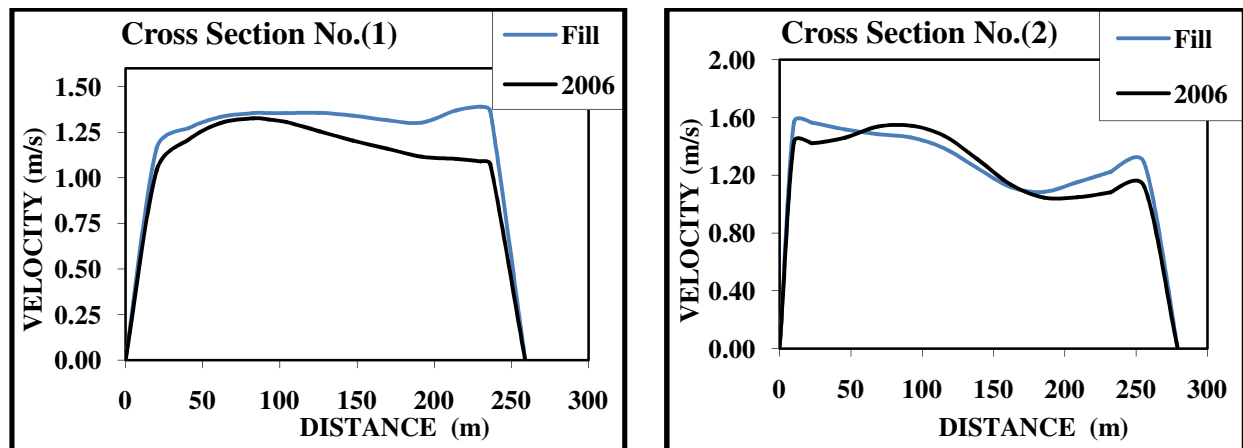
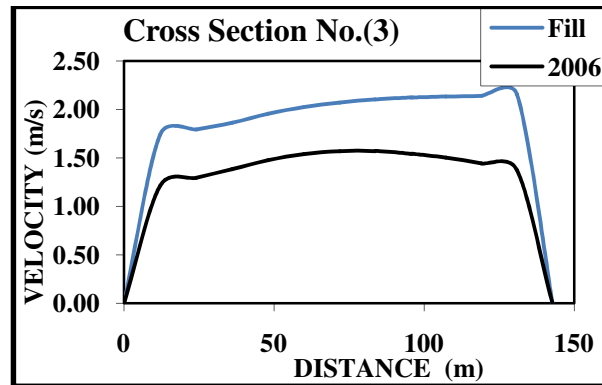
Fig. 14. Cross Sections Velocity Profile of the Original & Alternative (1) at Future Flow

The model was run at emergency discharge with its corresponding water levels. The discharge was $2546.30 \text{ m}^3/\text{s}$ and its corresponding water level was $+5.90 \text{ m MSL}$. The resulted velocities were ranged from 1.00 to 2.20 m/sec in the outer curve. While the average velocities of the reach were around 1.50 m/s . Fig. (14) shows the velocity profiles of alternative (1) in case of emergency flow comparing to the original results at cross sections No (1) to (3). The Fig. shows that the results of velocity profiles in case of alternate (1) were similar to the profiles as the original case. It is clear that the values of the velocities at cross sections 1&3 increased than in case of original case because of considerable part of those sections were filled.

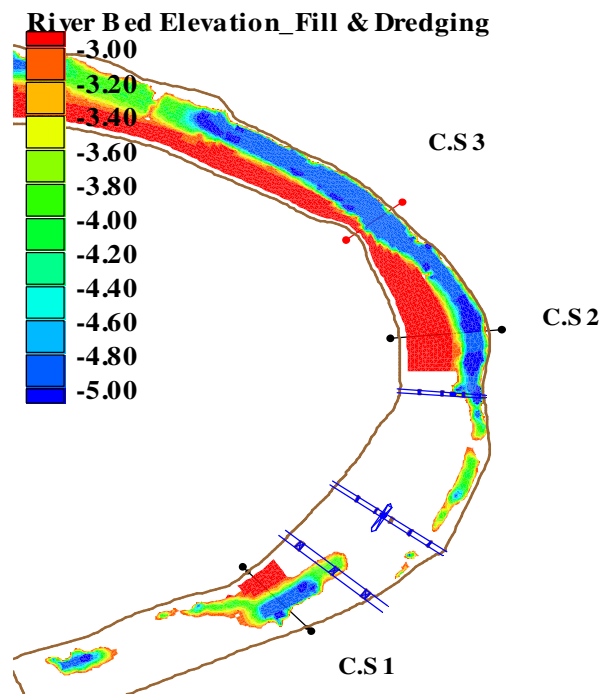
Fig. 15. River Bed Elevation in Case of Alternative (2)

The bed levels of the reach are filled to level -5.00 MSL and the other part are dredged to level +3.00 MSL to represent the second alternative. Fig. (15) shows the entire reach bed elevation in case of alternative 2. It is clear that the most of the filling areas are concentrated at the outer curves and the dredging area in the inner curve. These also are shown at Fig. (16), which represents three cross sections distributed along the reach. The location of these sections is shown in Fig. 15. The level of deepest point of the scour holes at cross sections from 1 to 3 are 2, 2 and 2 above MSL, respectively. This means that the filling layers of some holes are more than 12m and the dredging layers of some area within 5m.

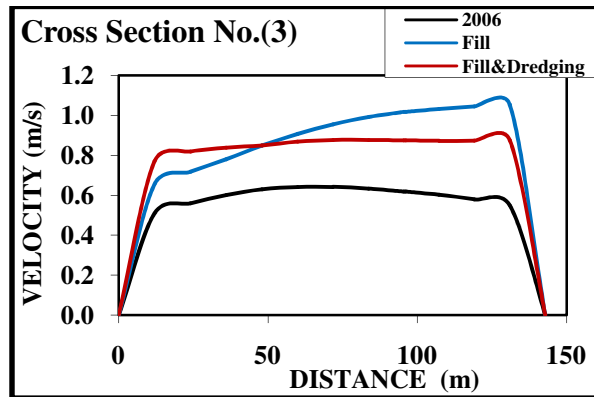
Fig. 17. Cross Sections Velocity Profile of the Original, Alternative 1 and Alternative 2 at Maximum Flow

In case of Maximum flow, the discharge was $809.03 \text{ m}^3/\text{s}$ and its corresponding water level was $+2.60 \text{ m}$ MSL. The flow velocities along the reach show that the maximum value of velocities was occurred at the outer curves. The resulted velocities are ranged between 0.28 and 0.93 m/sec at the concerned section. Fig. (17) shows the velocity profiles of alternative 2 comparing to the original results at cross sections No 1 to 3. The figure shows that the results of velocity profiles in case of alternative 2 were redistributed along the sections to be more regular than in case of the original at cross sections No 1 & 3. It is clear that the values of the velocities increased at cross section3 and decreased at cross sections No 2 comparing with the original case because of considerable part of those sections were filled and dredged respectively.

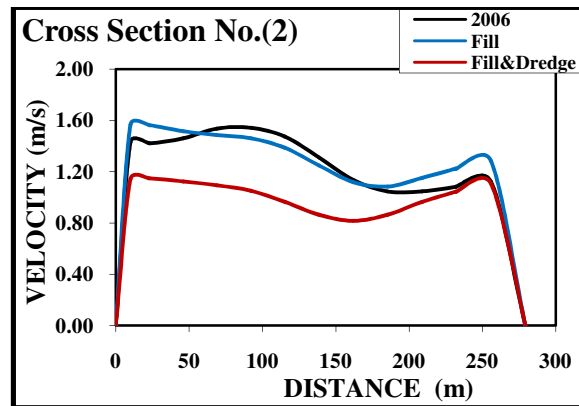
Fig. 18. Cross Sections Velocity Profile of the Original, Alternatives (1) and (2) at Emergency Flow

The model was run at emergency discharge with its corresponding water levels. The discharge was $2546.30 \text{ m}^3/\text{s}$ and its corresponding water level was +5.90 m MSL. The resulted velocities recorded in this case are ranged between 0.80 and 2.00 m/sec in the outer curve. While the average velocities along the reach were around 1.40 m/s.

Fig.(18) showed the velocity profiles at three cross sections along the reach for alternative 2 in the case of emergency flow compared to the basic case. The figure showed that the results of velocity profiles were redistributed along the cross sections to be more regular than the basic case at cross section No.1. It was declared that the velocities values were increased at cross section No.3 and decreased at cross section No. 2 compared to the basic case. That was resulted in the effective part of these sections were filled and dredged respectively.

7. In the case of alternative 2 the velocity profiles along the tested cross sections were redistributed and turned more regular compared to the alternative 1 and the basic case.
