SCOUR EVALUATION FOR THE NILE RIVER BENDS ON ROSETTA BRANCH

ABSTRACT

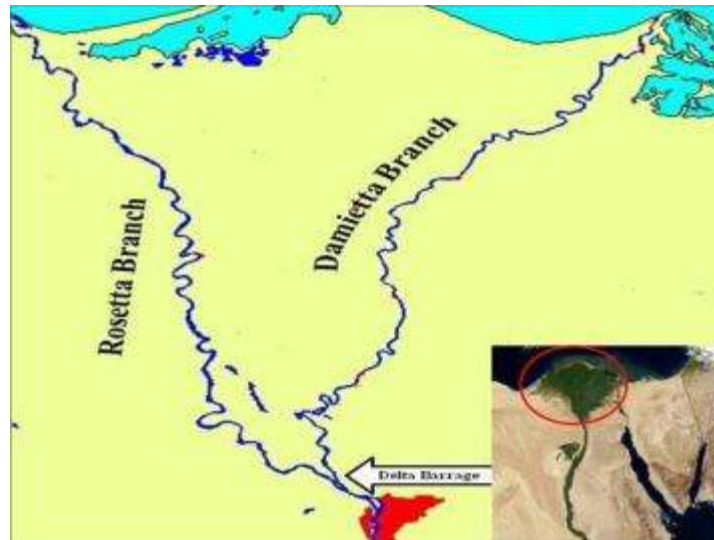
Fig. 1. Rosetta and Damietta Branches^[H3]

The average bed slope along the Damietta and Rosetta Branches of the Nile Delta (240km from Delta Barrage, Fig. (1) was 5.6cm/km. The suspended bed material loads for the Nile downstream Aswan has changed substantially as a result of the creation of Lake Nasser, [H1][H2][1].

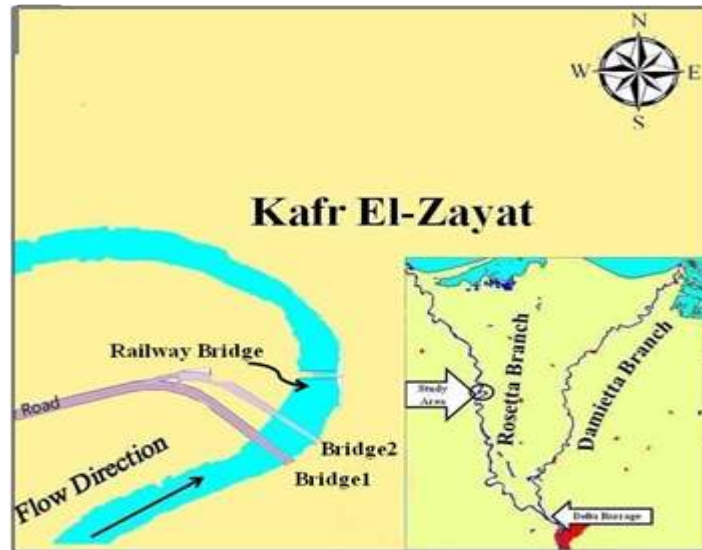
Fig. 2. Location of the Study Reach^[H5]

Kafr El-Zayat City is located at the outer curve of a very sharp bend at Km 123 of Rosetta Branch. The study area was 3.5km long, located downstream of Delta Barrage from km 145.00 to km 148.50 downstream of El-Roda Gauge Station. The study area is a bend consisting two highway bridges and one railway bridge were located. Fig-Figure (2) and Table (1) show the geometry and location of the 13 bridge piers and their distance from the left bank.

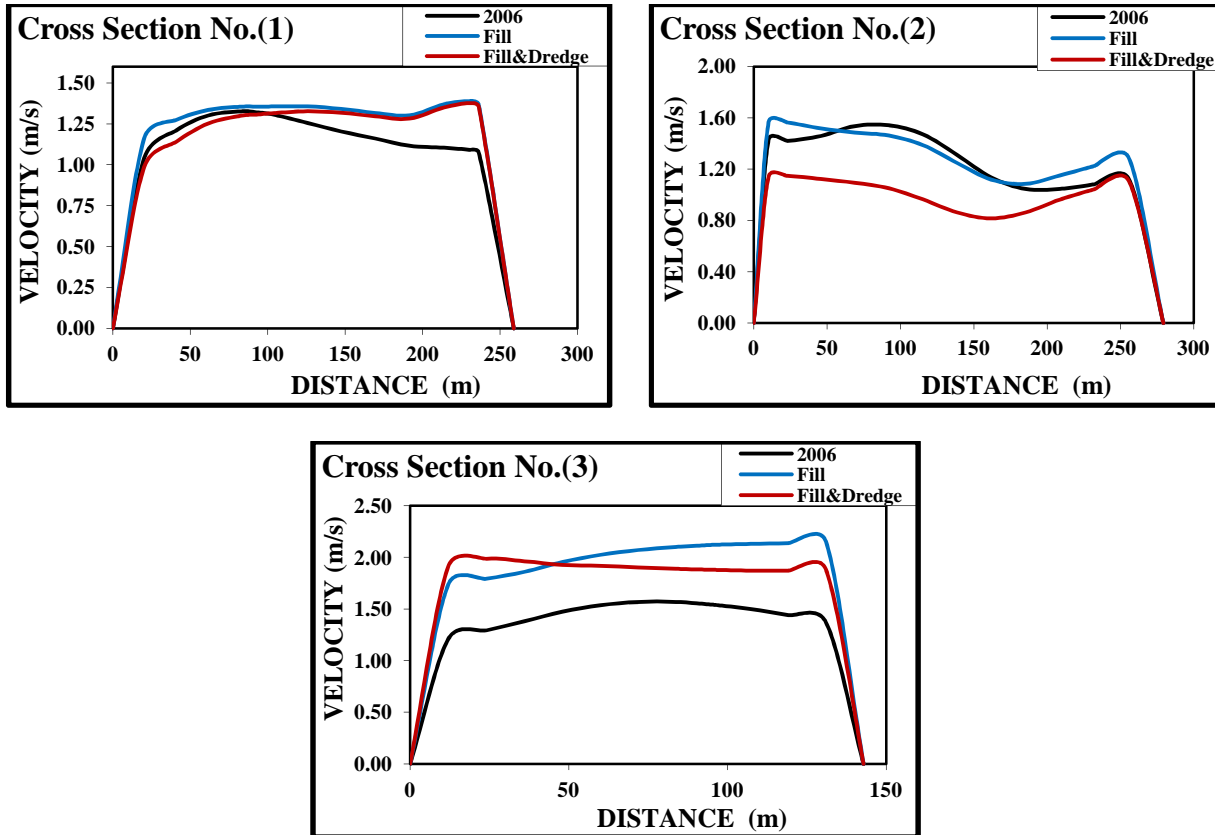
Fig. 18. Cross Sections Velocity Profile of the Original, Alternatives (1) and (2) at Emergency Flow

The model was run at emergency discharge with its corresponding water levels. The discharge was $2546.30\text{m}^3/\text{s}$ and its corresponding water level was $+5.90\text{ m}$ MSL. The resulted velocities recorded in this case are ranged between 0.80 and 2.00 m/sec in the outer curve. While the average velocities along the reach were around 1.40 m/s .

Figure-(18) showed the velocity profiles at three cross sections along the reach for alternative 2 in the case of emergency flow compared to the basic case. The figure showed that the results of velocity profiles were redistributed along the cross sections to be more regular than the basic case at cross section No.1. It was declared that the velocities values were increased at cross section No.3 and decreased at cross section No. 2 compared to the basic case. That was resulted in the effective part of these sections were filled and dredged respectively.

7. In the case of alternative 2 the velocity profiles along the tested cross sections were redistributed and turned more regular compared to the alternative 1 and the basic case.
