Review article Non-destructive Microcracks Detection Techniques in Silicon Solar Cell Mohd Israil*, Abdul Ghani Yousseph Kerm Department of physics, Aljouf University, Sakaka 2014, Aljouf, Kingdom of Saudi Arabia ABSTRACT A very high demand and limited stock of fossil fuels, renewable energy in very particular solar energy is the mainly focused area for research these days. This review paper presents the nondestructive optical testing techniques for the solar cells. The impacts of microcracks in solar cells as well as photovoltaic modules have been studied in this paper. Laser beam induced current, electron beam induced current, electroluminescence and photoluminescence are mainly discussed techniques in this paper. All the aforementioned methods will be reviewed, highlighting some of their salient characteristics including merits and demerits. For completion and thoroughness, some image processing techniques for the shape and size detection of micro-cracks will also be discussed

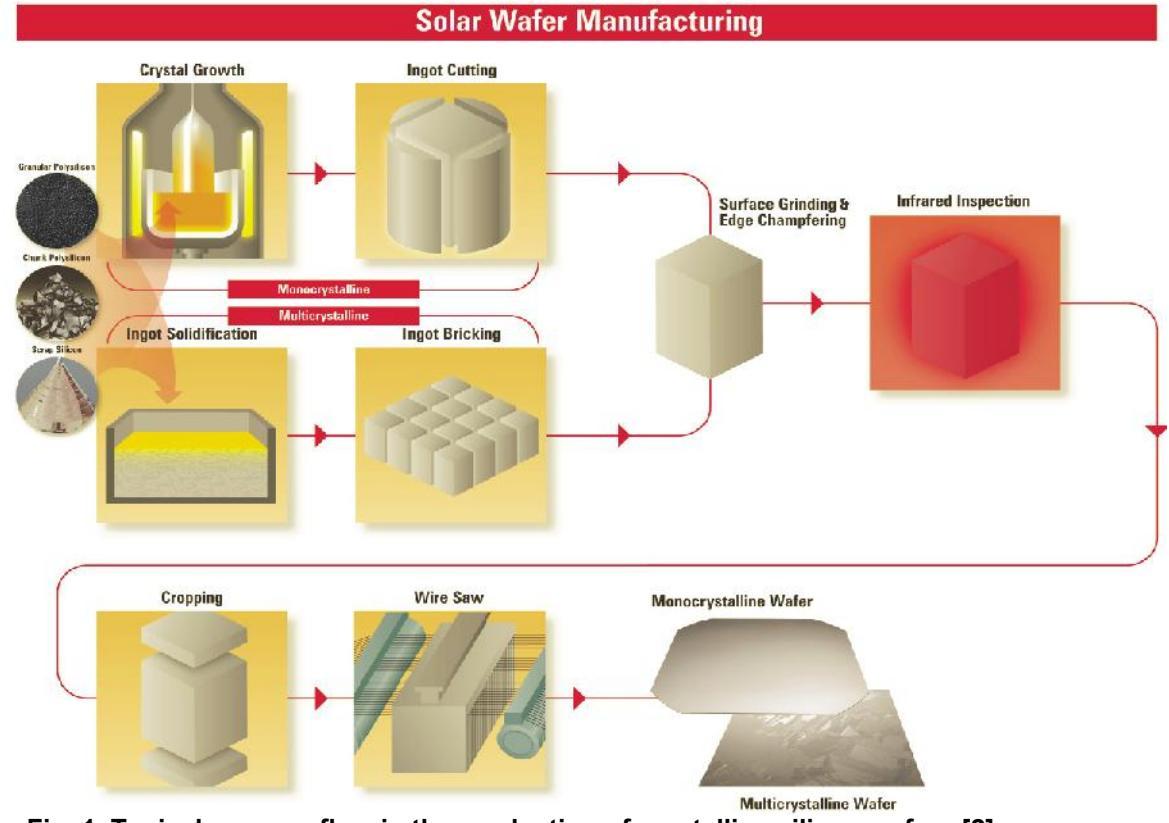
Fig. 1. Typical process flow in the production of crystalline silicon wafers [2]

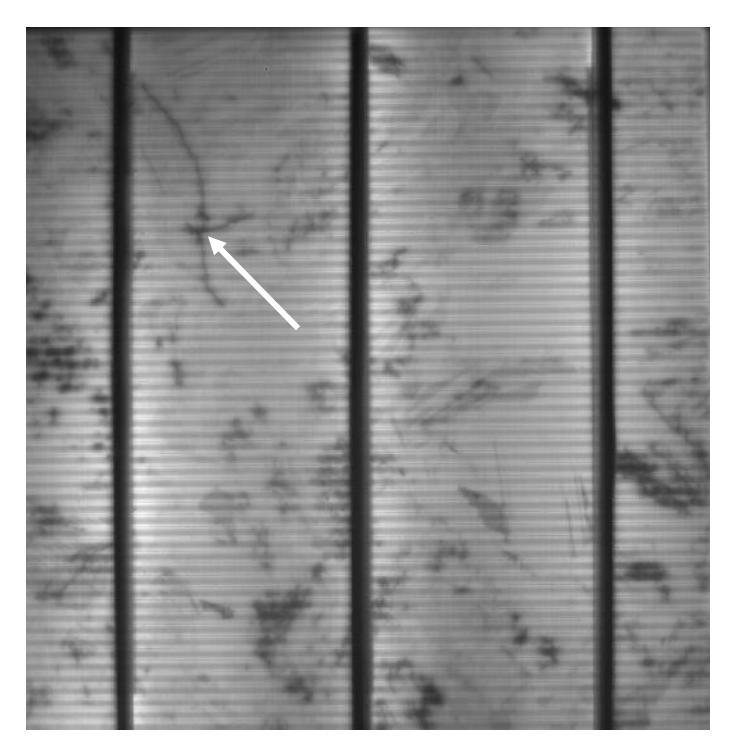
Fig. 2. Example of polycrystalline solar wafer with micro-crack

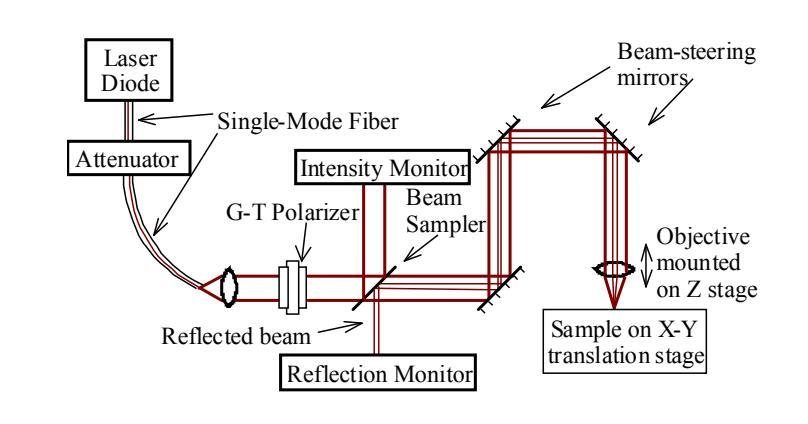
Fig. 3. LBIC Measurement Setup

81 LBIC is a non-destructive optical testing for the characterization of semiconductors [16-17]. The basic LBIC system setup is shown in figure 3. As shown in this figure, the light source is 82 83 selected from laser diodes of different wavelengths between 638 and 850 nm, and an 84 electrical current to the laser diode is electronically modulated to produce an AC laser beam, 85 and the modulation also provides the reference signal for a lock-in amplifier. When a light

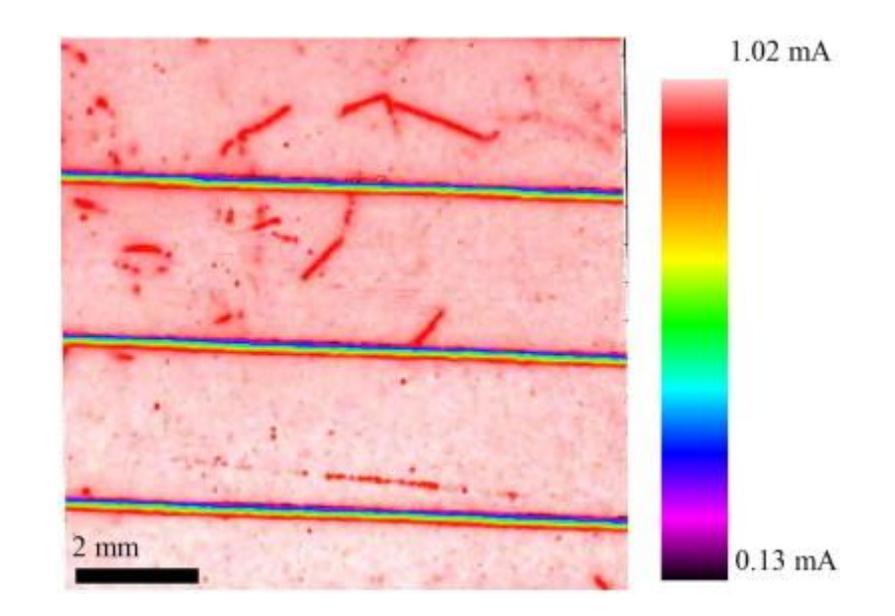
Fig. 4. LBIC map of Polycrystalline silicon solar cell [18]

110 Figure 4 shows the current distribution map of the cell obtained through LBIC imaging. In this 111 figure, the dark irregular lines correspond to the active performance degrading grain 112 boundaries. Figure 5(a) shows the LBIC reflection map corresponding to the darker areas of 113 Figure 4. It is evident that the current distribution, as expected for multi-crystalline material, 114 is not uniform as illustrated in regions marked A-C. The uniformity is compromised by the reflection and absorption of different grains at the surface of the polycrystalline silicon solar 115 cell. Light is reflected more in region C than the neighboring regions A and B. In Figure 5(b), 116 117 reflective line scan is depicted, which further indicates the high current response in region C. 118 This region is expected to decrease the efficiency of the solar cell when it is in operation. The feature indicated by X corresponds to the grain boundary which clearly reflects more 119 120 incident light as do the contact fingers.

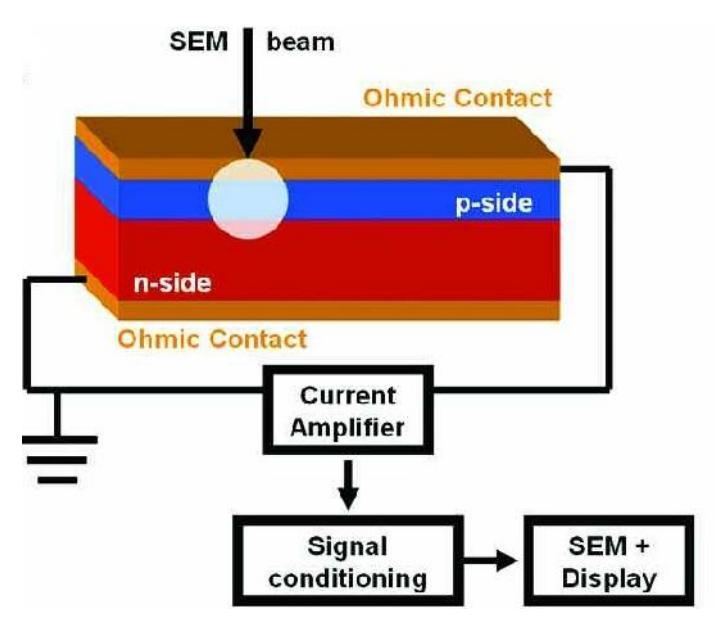
Fig. 6. EBIC Imaging Systems

178 Referring to figure 6, the wire that carries the current away from the top contact can be seen 179 in the lower left. The solar cell is slowly scanned and the EBIC current given by Equation (2) 180 is then measured. This current is displayed in color. The measured EBIC current was small 181 when the beam fell on the metal contact but was larger when it fell on the active region of the 182 solar cell. Figure 7 shows a secondary electron image of a polycrystalline silicon solar cell. 183 Within the active region of the solar cell there are large variations in the current. This is due 184 to a variation in the density of defects which causes the electron-hole pairs to recombine 185 before they are separated by the built-in electric field. Figure 8 illustrates a typical EBIC 186 image when the electron beam energy is 20 keV [11]. The crack can be clearly seen in the image. Therefore this technique is useful to detect the presence or absence of micro-crack in 187 188 solar cell or solar wafer.

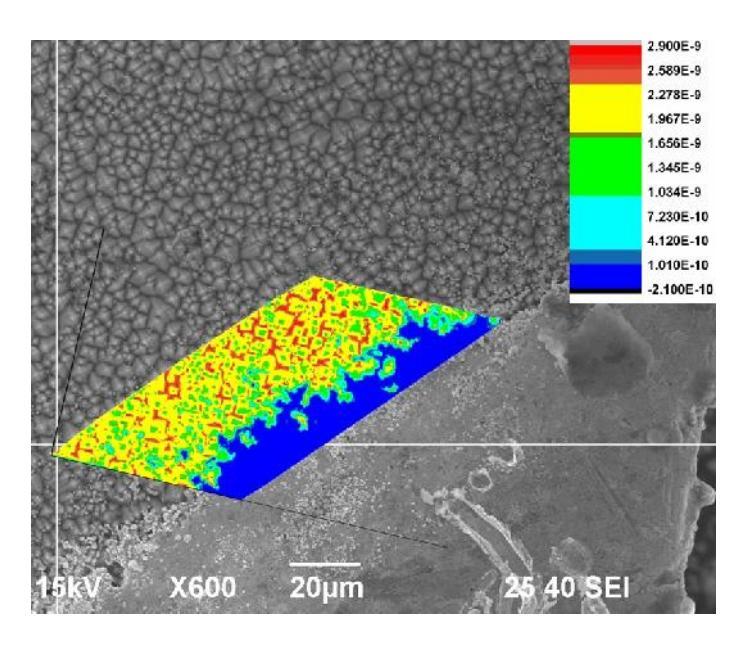
Fig. 7. EBIC current map of a polycrystalline silicon solar cell

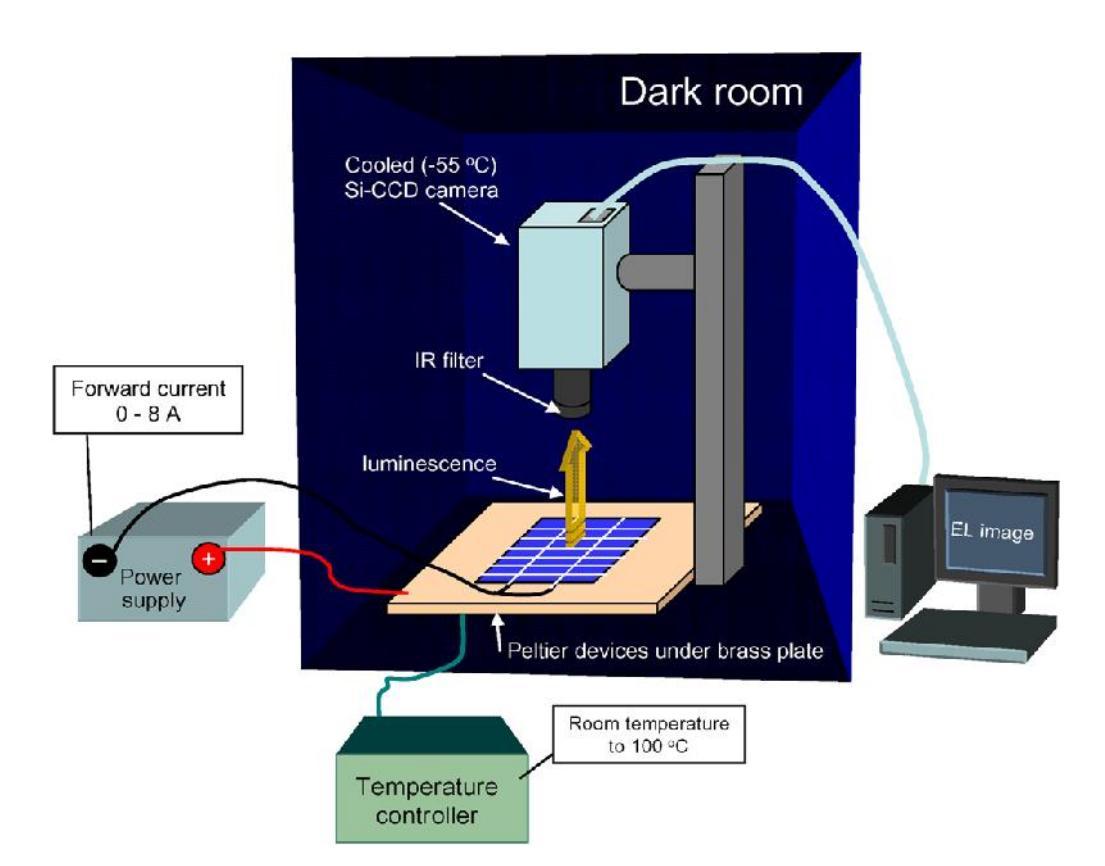
Fig. 9. A typical set up for Electroluminescence [15]

finished cell but also to the module and solar panels. The typical set-up for electroluminescence based inspection system is shown in Figure 9. It shows the solar cell sample connected to a power supply, a Silicon-CCD camera used to capture the picture which is then processed by the work station.

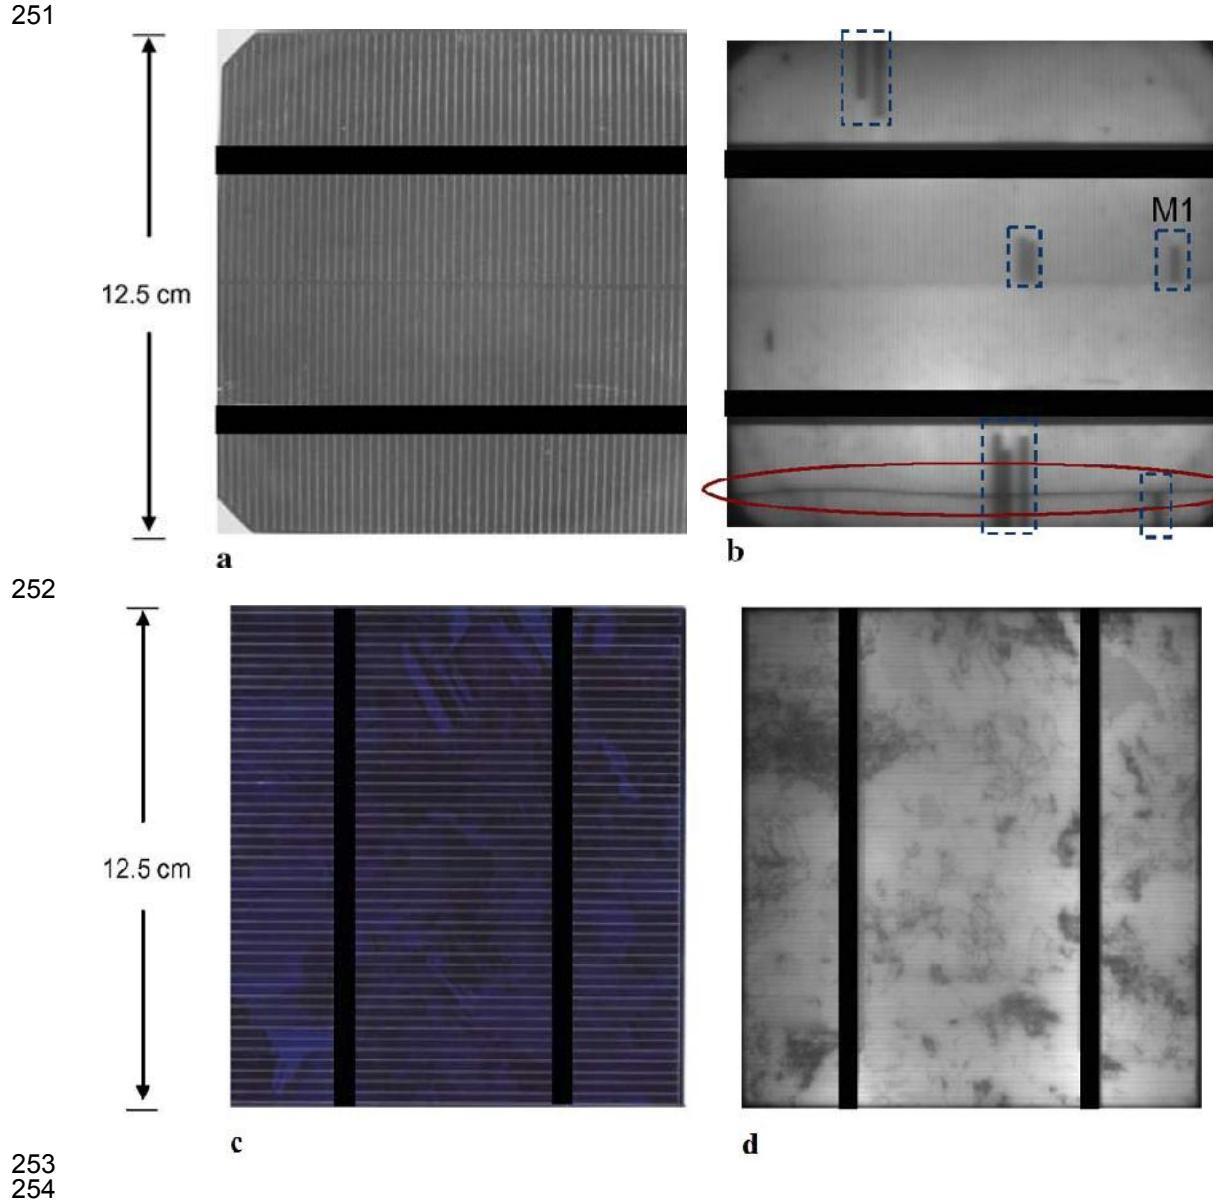
Fig. 10. (a) Optical image of a defected monocrystalline silicon solar cell, (b) 255 the corresponding EL image of (a), (c) optical image of defected 256 polycrystalline silicon solar cell, (d) the corresponding EL image of (c) [15] 257

234 Figure 10 (a) shows the sample of optical image of the defected monocrystalline silicon solar 235 cell, whereas Figure 10(b) shows the EL image of the same cell. The presence of horizontal 236 line can easily be seen in the bottom part of the Figure 10(b). This horizontal line is a crack 237 present in the cell which cannot be seen in the Figure 10(a). Meanwhile Figure 10(d) shows 238 an EL image of the polycrystalline silicon cell in which the grain boundaries became visible; 239 those are not visible in the optical image as shown in Figure 10(c). The beauty of this system is that it can be applied for the wafer, cell as well as photovoltaic module. Figure 11 shows 240 241 EL image of the monocrystalline photovoltaic (PV) module reported by [22]. The CCD image 242 of the monocrystalline photovoltaic module acquired at delivery is shown in Figure 11(a),

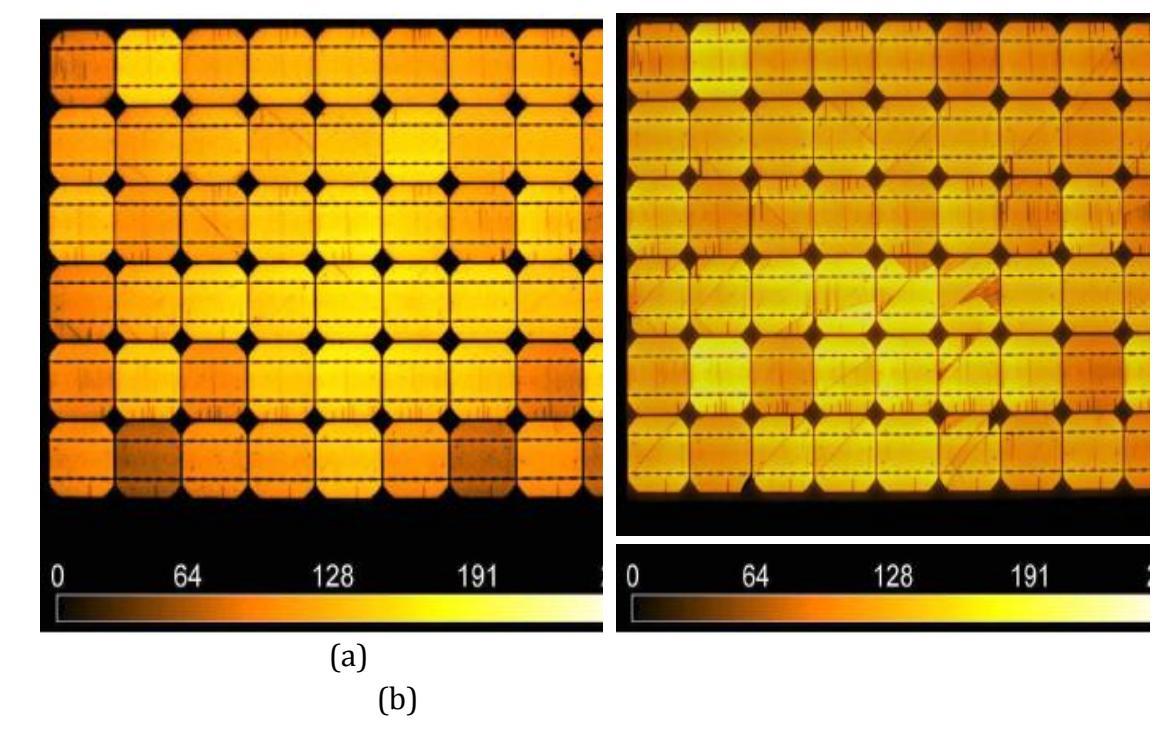
Fig. 11. EL images of a PV module (a) at delivery status (b) after exposed to temperature change

243 while Figure 11(b) shows the corresponding EL image. The presence of manufacturing 244 defects like crack in the module is not clearly visible in Figure 11(a).

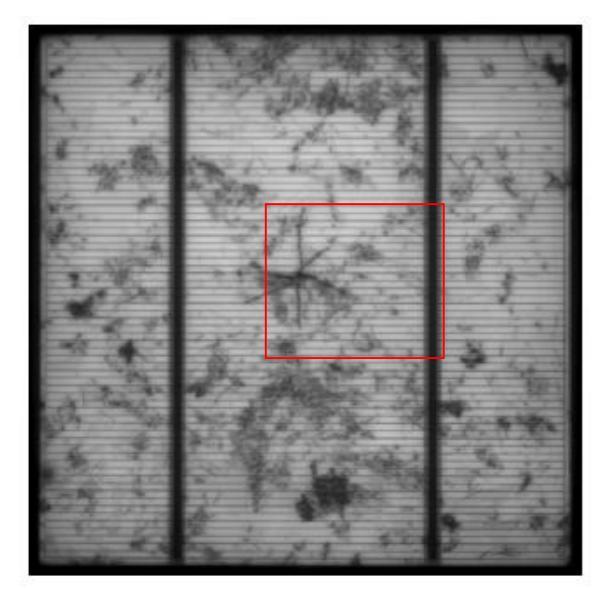
Fig. 13. Example of PL image of a polycrystalline silicon solar cell with micro-crack in the red box

More defects in the silicon will result in more energy lost as heat, and fewer emitted photons. In contrast fewer defects in the silicon will result in more radiative recombination, and more emitted photons. Example of the PL image of the polycrystalline silicon solar cell is given in figure 13 [25], showing the presence of micro-cracks and they are highlighted in a red square box. PL imaging is an efficient technique as it does not require any electrical contact and the image taken by this technique is free from series resistance. It can be applied to wafer, cell as well as module.
