SCOUR EVALUATION FOR THE NILE RIVER BENDS ON ROSETTA BRANCH

ABSTRACT

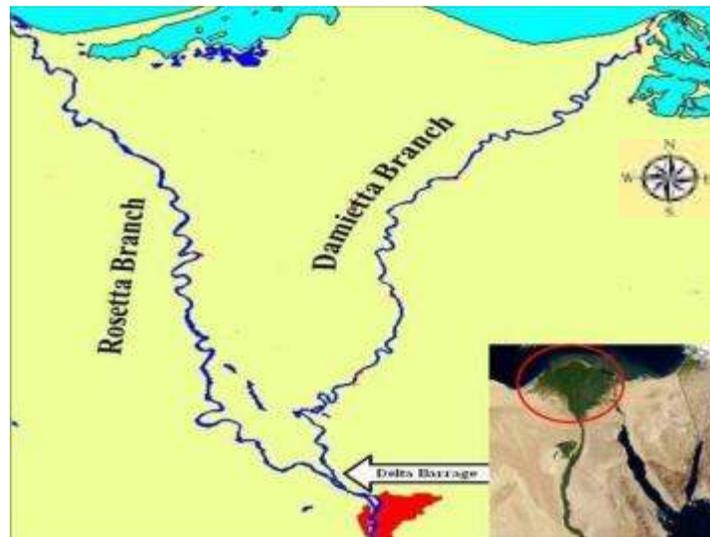
Fig. 1. Schematic Sketch for Rosetta and Damietta Branches

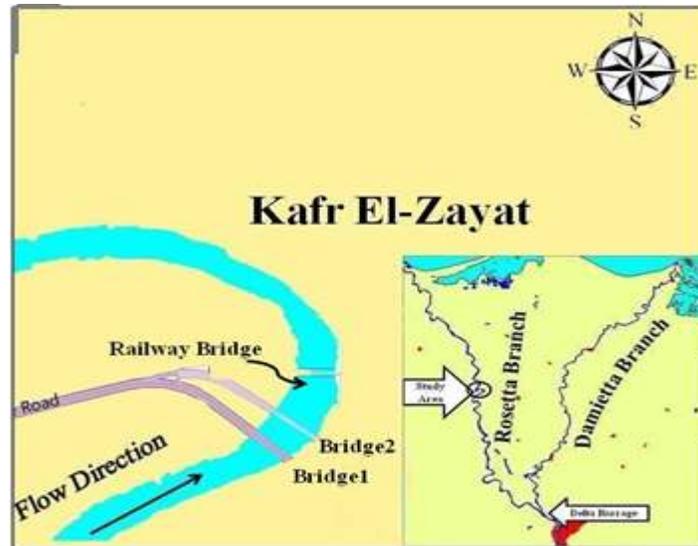
Kafr El-Zayat City is located at the outer curve of a very sharp bend at Km 123 of Rosetta Branch. The study area was 3.5km long, located downstream of Delta Barrage from km 145.00 to km 148.50 downstream of El-Roda Gauge Station. The study area is a bend consisting two highway bridges and one railway bridge were located. Figure (2) and Table (1) showed the geometry and location of the 13 bridge piers and their distance from the left bank. It should be denoted that the coordinates of the study area were (289181.00 m E, 3410603.00 m N), and (287432.08 m E, 3413467.01 m N) UTM

Fig.2. Schematic Sketch for the Study Reach

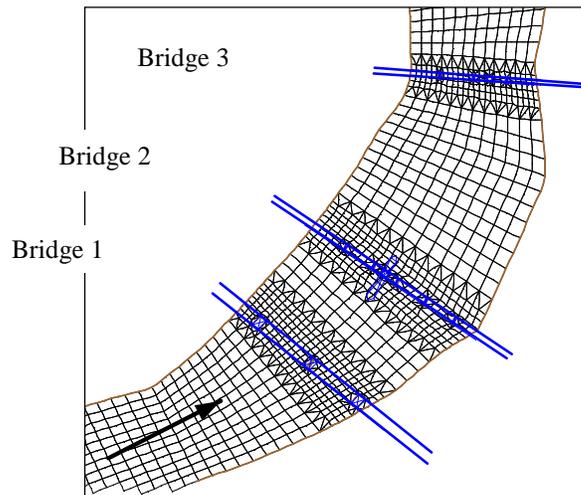
The simulated length was about 3.5km, including 13 piers under 3 bridges. The mesh was generated for the studied area, and the bed elevations were determined using the bathymetric survey of the river. The mesh was designed by dividing the studied reach into different regions. Each region was divided into elements called quadrilateral elements and triangular elements. It should be mentioned that the designed mesh was condensed at the locations of the bridge piers to simulate the dimensions of piers with high accuracy Fig. (3). The depth file was created based on the hydrographic survey data collected in 2006. The discharge and the water level were used as upstream and downstream boundary conditions respectively. The hydraulic roughness coefficient was defined at each grid point and ranged from 0.02 to 0.05.

Fig.3. Mesh Generation

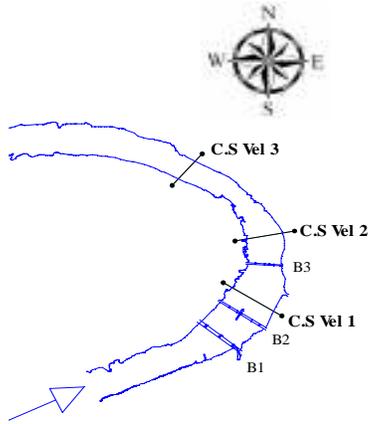
The model was run using the field hydraulic measurements in 2006. The discharge of $222.8\text{m}^3/\text{sec}$ and the corresponding water level of 2m MSL were used as upstream and downstream boundary conditions respectively. In calibration process, the velocity distributions were located at 3 different cross sections, Fig. (4). The water surface slope was adjusted in the model by changing the roughness coefficient up to a good agreement between the prototype, and model water surface slope was obtained after which the roughness coefficient was fixed. Figures (5-7) showed good agreement between the velocities obtained from the used model and field measurements at different cross sections. The presented velocity distribution was agreed with [16].

Fig. 4. Location of the Calibration Cross Sections

The survey data on year 2006 were used in the simulation as the most updated measurements for the present conditions. Within this reach, (2) bridges were presented, one for railway and two for highways. Also, the river bank in front of Kafr El-Zayat were included. The calibration of the hydrodynamic model was carried out by comparing the predicted velocities obtained from the numerical model and the corresponding field measurements at the 3 cross sections presented in Fig. (4).

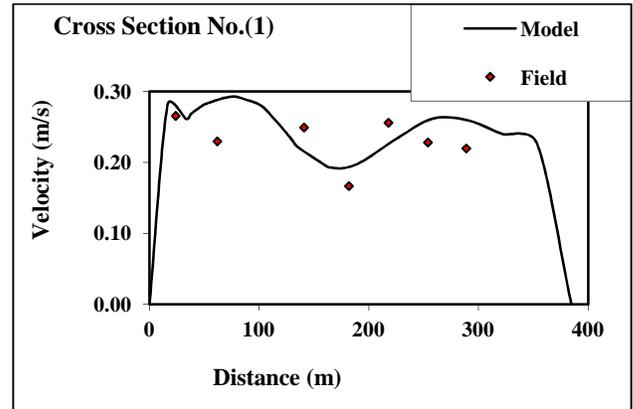
Fig. 5. Flow Velocity Calibration at Cross Section (1)

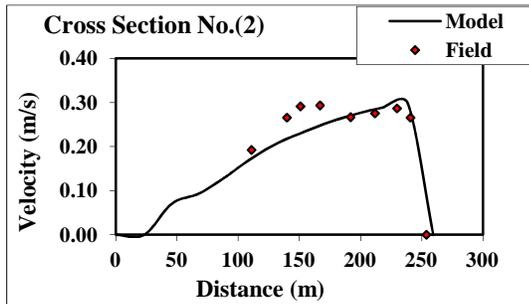
Fig. 6. Flow Velocity Calibration at Cross Section (2)

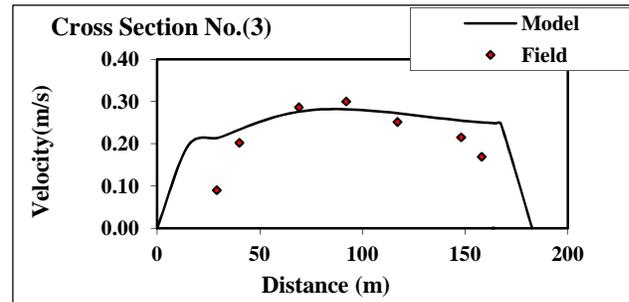
Fig. 7. Flow Velocity Calibration at Cross Section (3)

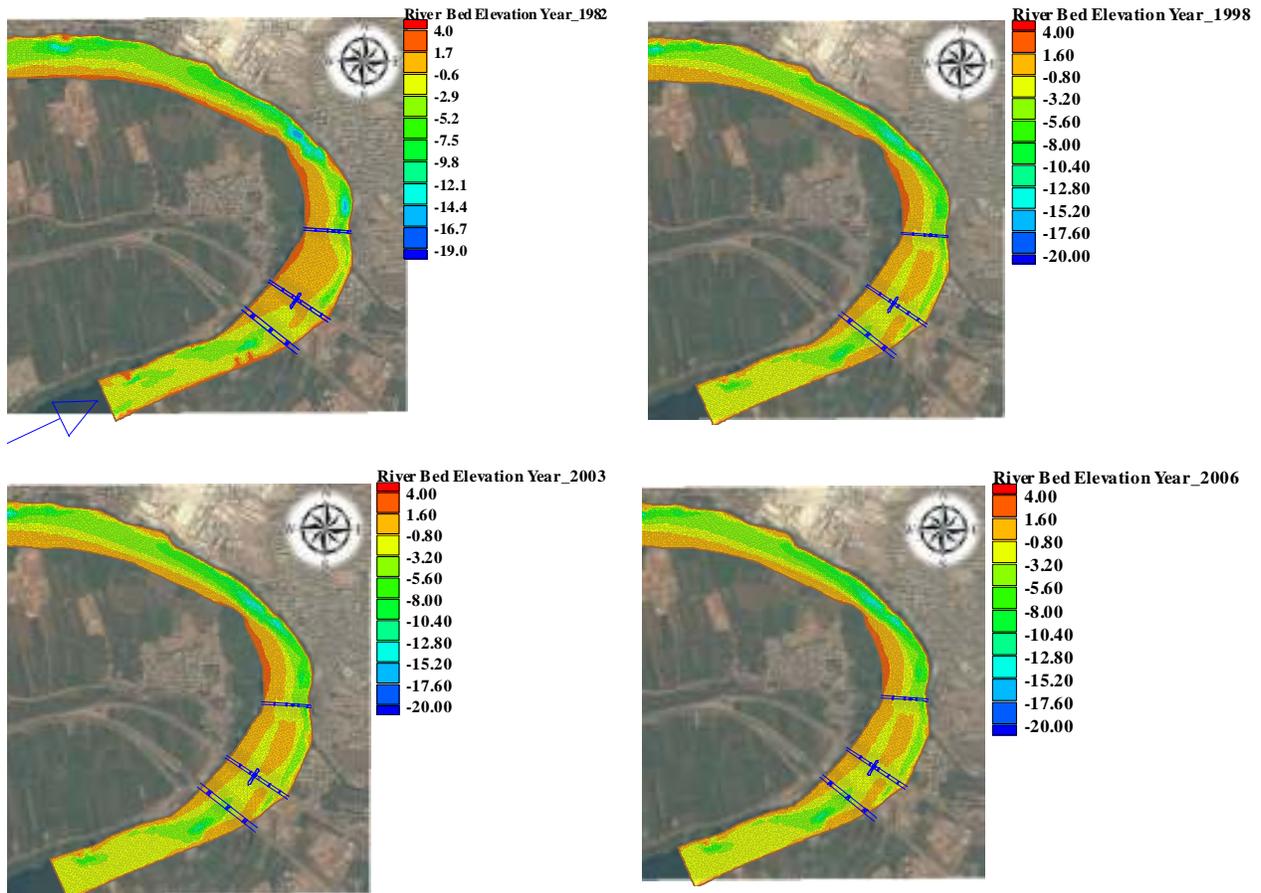
A comparison in bed profiles along the study reach during years 1982, 1998, 2003 and 2006 was presented in Fig. (8). The figure showed that, most of the studied area was exposed to the scouring action. Moreover, the maximum scour occurred at the outer bank on the contrary the deposition region.

Fig.8. River Bed Elevation at Years 1982, 1998, 2003 and 2006

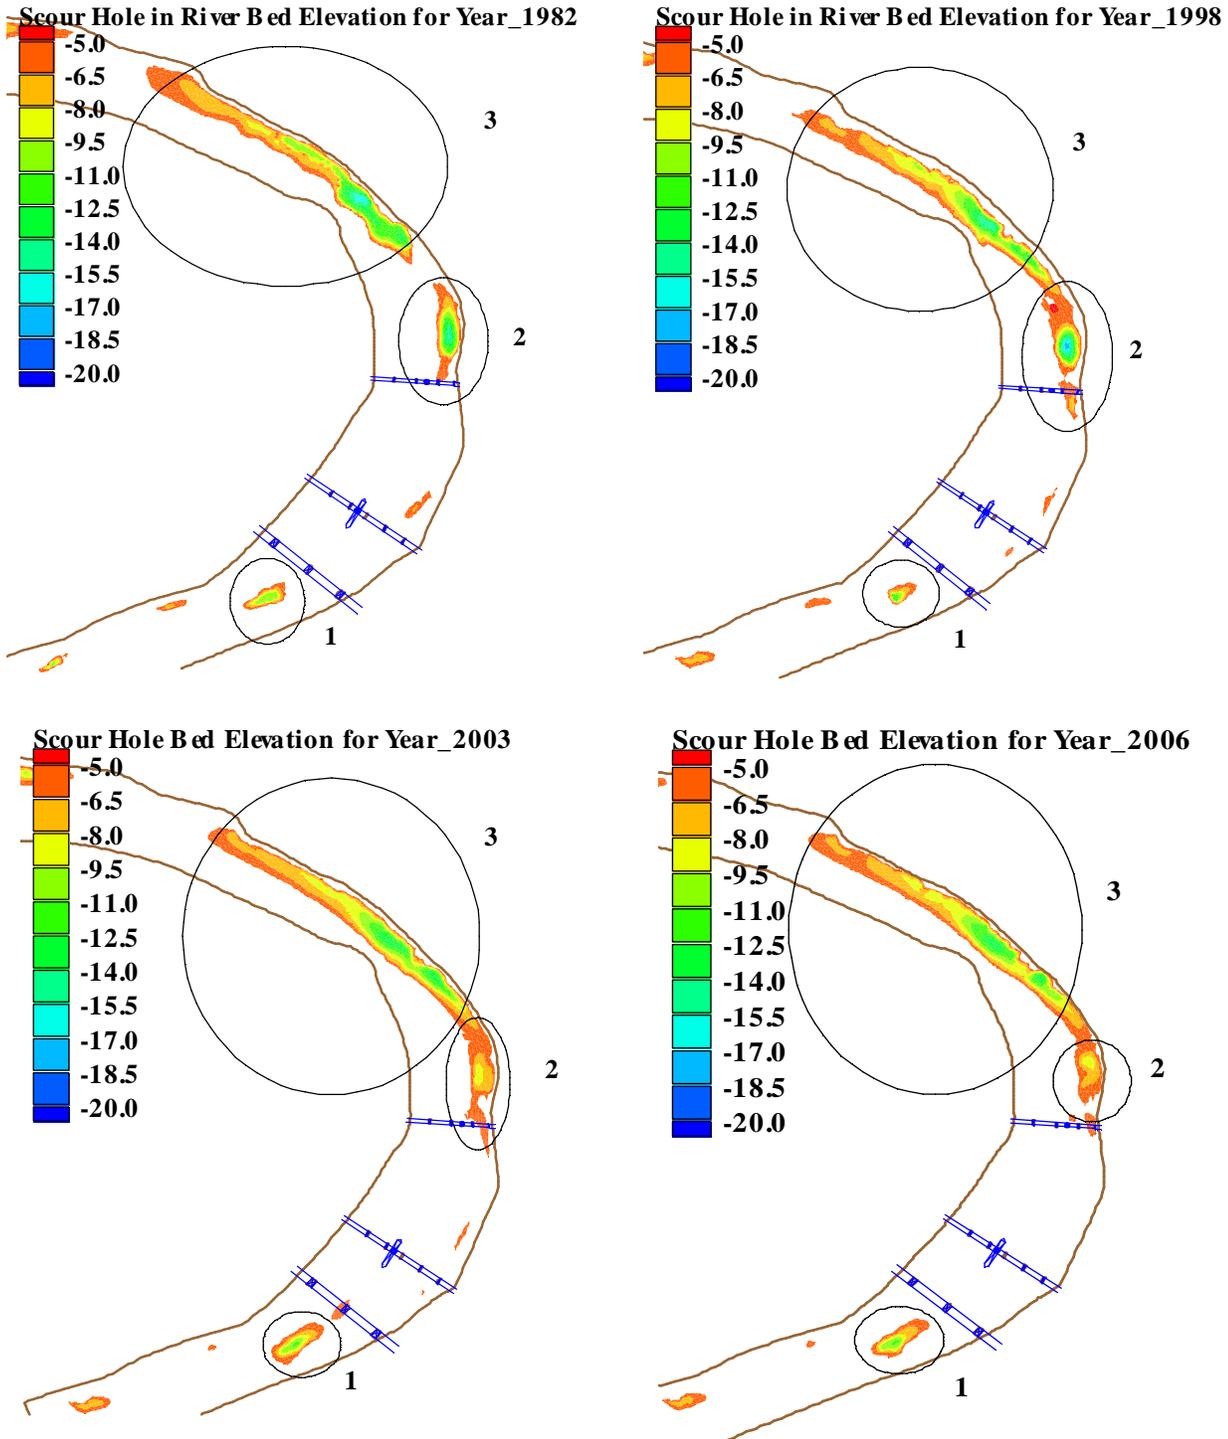
The location and the geometry development of the scour holes in the studied area from years 1982 to 2006 was showed in Fig. (9). In the outer curve, the velocity was higher than inner curve. Consequently, the scour holes were located at the outer curve of the meander which in turn exposes it to the risk of failure. From figure investigations it was dedicated that the area of scour holes No.1 were wider in year 2006 than year 1982, however the scour holes No.2 &3 were deposited in the same time period. The output findings were found to be match with the results obtained by [17].

Fig.9. Scour Holes Location in the Study Area at Years 1982, 1998, 2003 & 2006

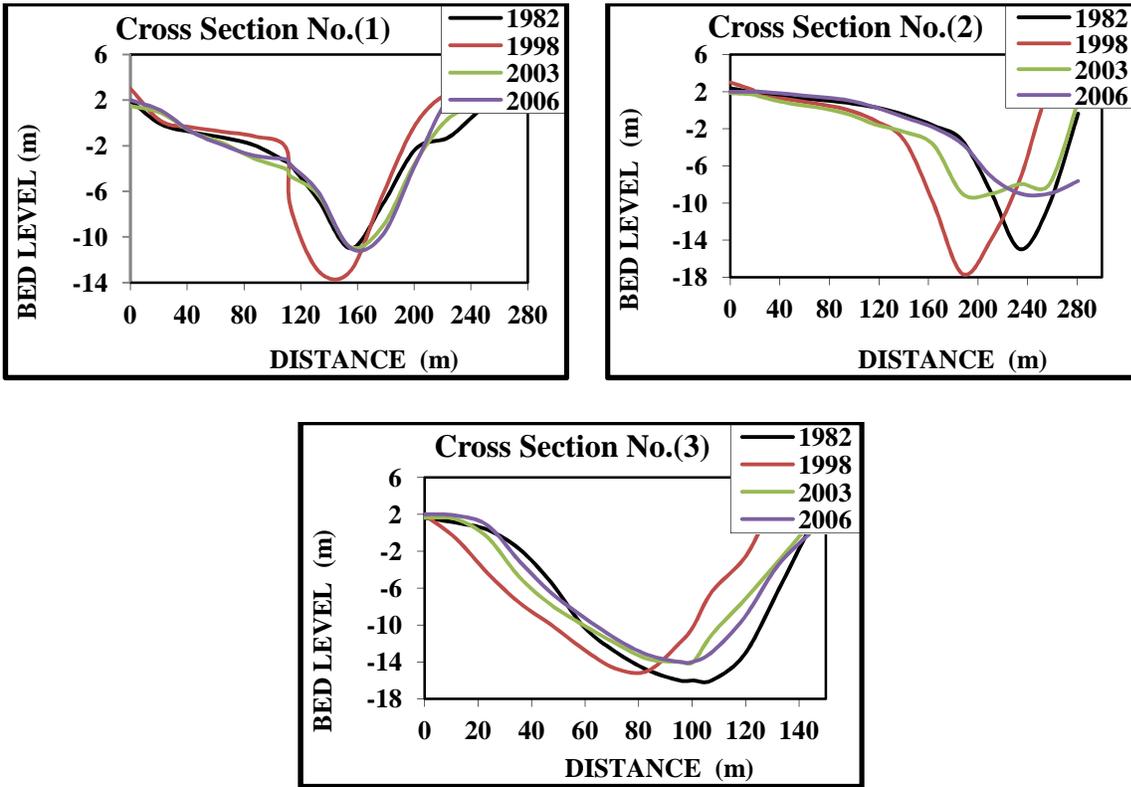
A comparison between the geometry of scour holes at different cross sections at years 1982, 1998, 2003 and 2006 was presented in Fig. (10). It was noticed that for the tested cross sections the scour holes became the deeper and shifted to the left side on 1998 when compared to other years. This owned to the high flood occurred in this year. Focusing on cross section 3, the geometry of scour hole was on a large scale due to its location; just downstream the bridge piers and narrow width.

Fig.10. Geometry of Scour Holes at different Cross Sections for Years 1982, 1998, 2003 and 2006

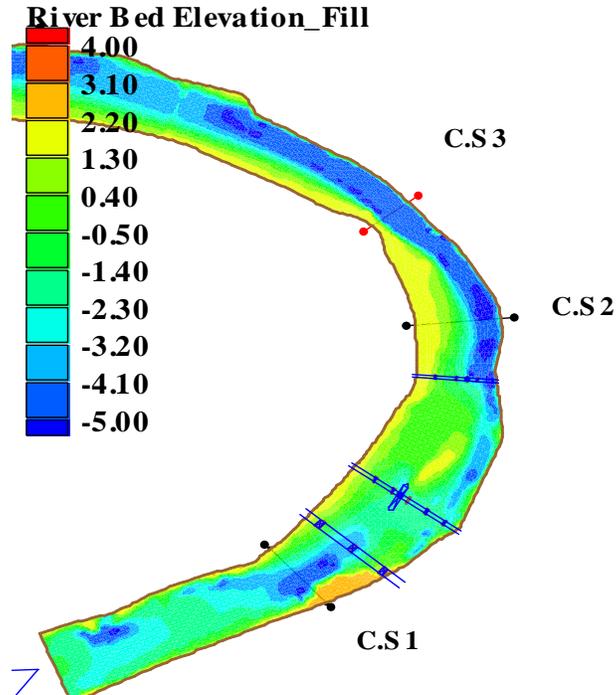
The bed levels of the reach after filled with filling materials to level -5.00 MSL were presented in Fig. (11) to simulate the first alternative. It was noticed that the most of the filling areas were concentrated at the outer curves where the scour regions were highlighted. These also were illustrated in Fig. (12) that presented (3) cross sections distributed along the reach. The locations of these sections were presented in Fig. (11) and were selected after carefully study for the entire reach to present the maximum bed morphological changes.

Fig. 11. River Bed Elevation in the Case of Alternative (1)

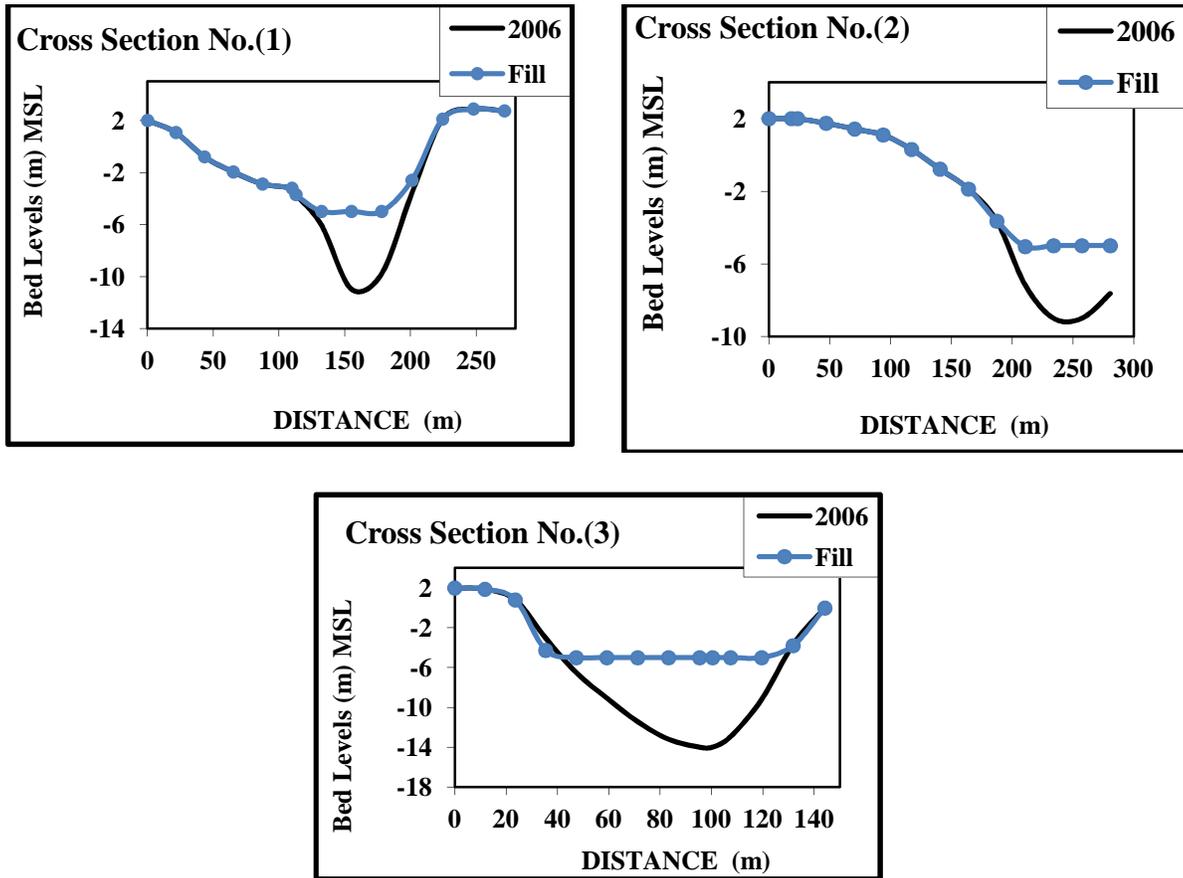
The maximum depth of the scour holes at cross sections 1, 2, and 3 were -11, -9 and -14 MSL, respectively. Consequently, the depth of filling layers was more than 12m for some holes.

Fig.12. Bed Profiles at Different Cross Sections after Simulating Alternative (1)

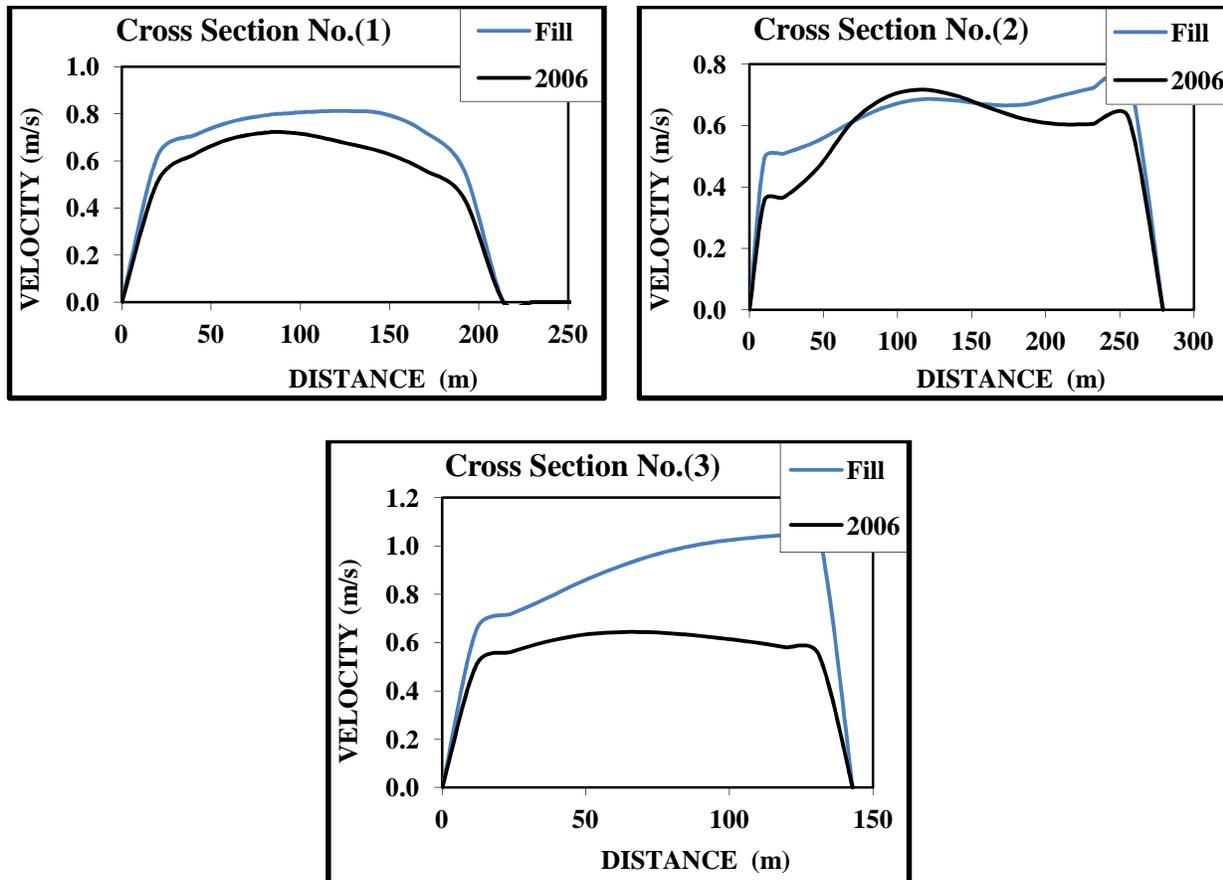
The velocity profiles of alternative (1) compared to the basic case at different cross sections were presented in Fig. (13). The same curves trend was found. Moreover, it was declared that the velocity values were higher than the basic case resulted in decreasing the cross sectional area after filling.

Fig.13. Velocity Profiles for the **Basic** Case and Alternative (1) for the Max. Flow

In case of Maximum flow, the discharge was $809.03\text{m}^3/\text{s}$ and its corresponding water level was $+2.60\text{m}$ MSL. The predicted velocities were ranged from 0.45 to $1.05\text{m}/\text{sec}$ in the outer curve for different cross sections. However, the average velocities of the reach were around $0.70\text{ m}/\text{s}$.

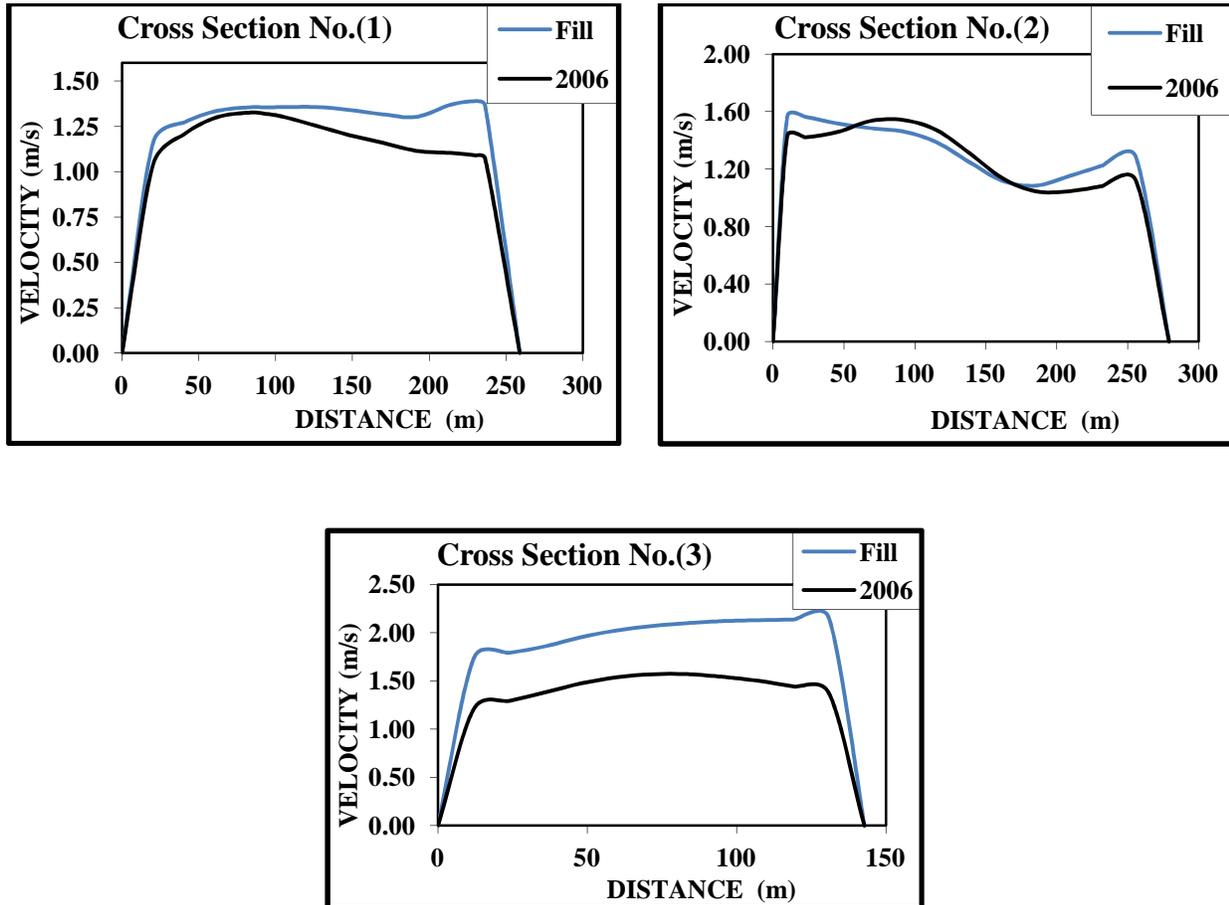
The velocity profiles of alternative (1) in case of emergency flow comparing to the basic results at cross sections No (1) to (3) were presented in Fig. (14). The figure demonstrated that the results of velocity profiles in case of alternate (1) were similar to the profiles as the **basic** case. Clearly, the values of the velocities at cross sections 1&3 increased than in case of **basic** case because of considerable part of those sections were filled.

Fig.14. Velocity Profiles for the Basic & Alternative (1) at Future Flow Conditions

The model was run at emergency discharge with its corresponding water levels. The discharge was $2546.30\text{m}^3/\text{s}$ and its corresponding water level was $+5.90\text{m}$ MSL. The resulted velocities were ranged from 1.00 to $2.20\text{m}/\text{sec}$ in the outer curve. While the average velocities of the reach were around $1.50\text{m}/\text{s}$.

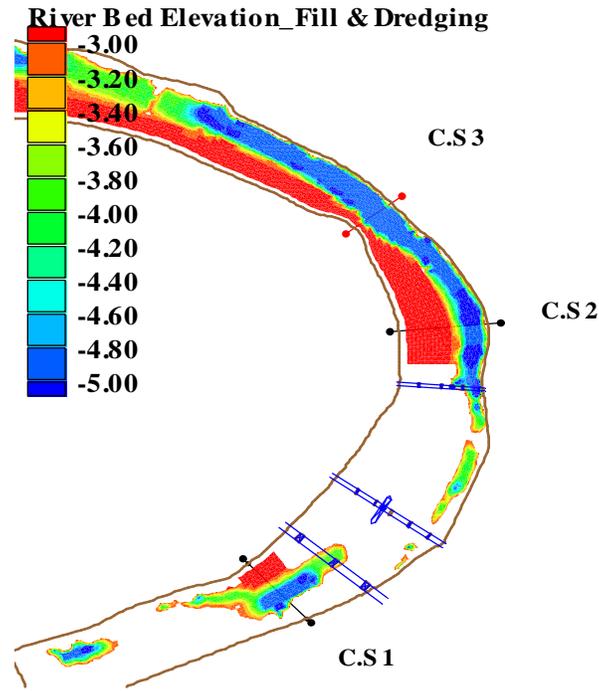
The bed levels of the reach are filled to level -5.00 MSL and the other part are dredged to level +3.00 MSL to represent the second alternative. Figure (15) showed the entire reach bed elevation in the case of alternative 2. It was cleared that the most of the filling areas were concentrated at the outer curves and the dredging area in the inner curve. These also were showed in Fig. (16), which represented three cross sections distributed along the reach. The location of these sections showed in Fig. (15). The filling layers of some holes were more than 12m and the dredging layers at some locations were within 5m.

Fig.15. River Bed Elevation in the Case of Alternative (2)

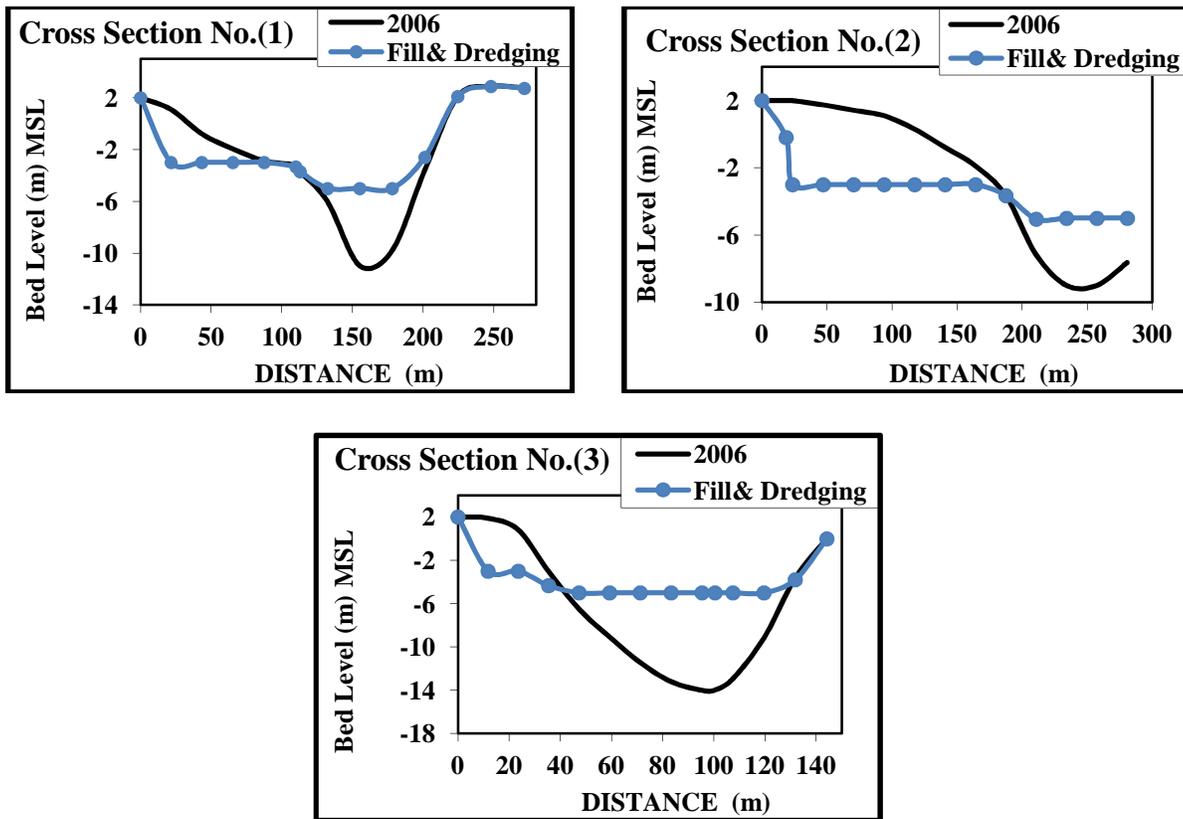
Fig.16. Bed Profiles at Different Cross Sections for the Basic Case and Alternative (2)

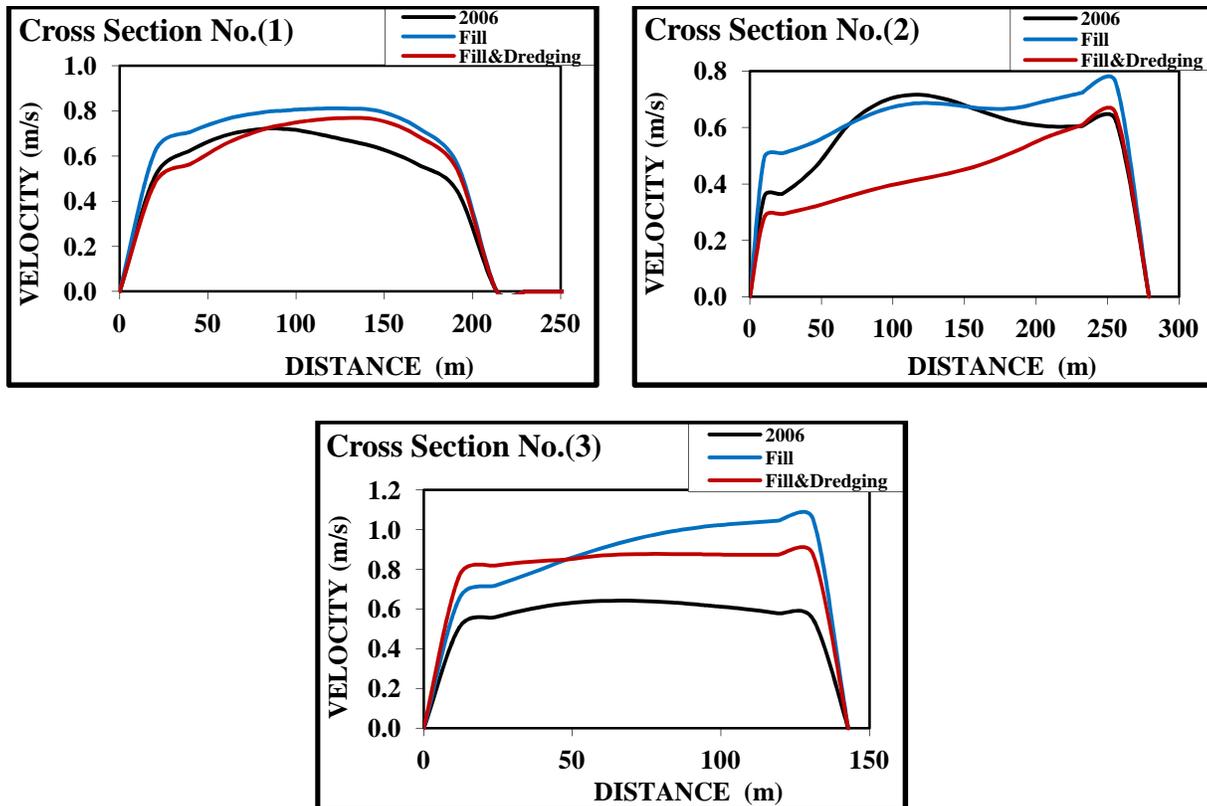
In case of Maximum flow, the discharge was $809.03\text{m}^3/\text{s}$ and its corresponding water level was $+2.60\text{m}$ MSL. The flow velocities along the reach show that the maximum value of velocities was occurred at the outer curves. The resulted velocities were ranged between 0.28 and 0.93 m/sec at the concerned section. The velocity profiles of alternative 2 compared to the basic results at cross sections No. 1 to 3 were showed in Fig. (17). The figure illustrated that the results of velocity profiles in case of alternative 2 were redistributed along the sections to be more regular than in case of the basic case at cross sections No. 1 & 3. Consequently, the velocity values were increased at cross section 3 and decreased at cross sections No. 2 compared to the basic case because of considerable part of those sections were filled and dredged respectively.

Fig.17. Velocity Profiles for the Basic, Alternatives (1) and (2) at Maximum Flow

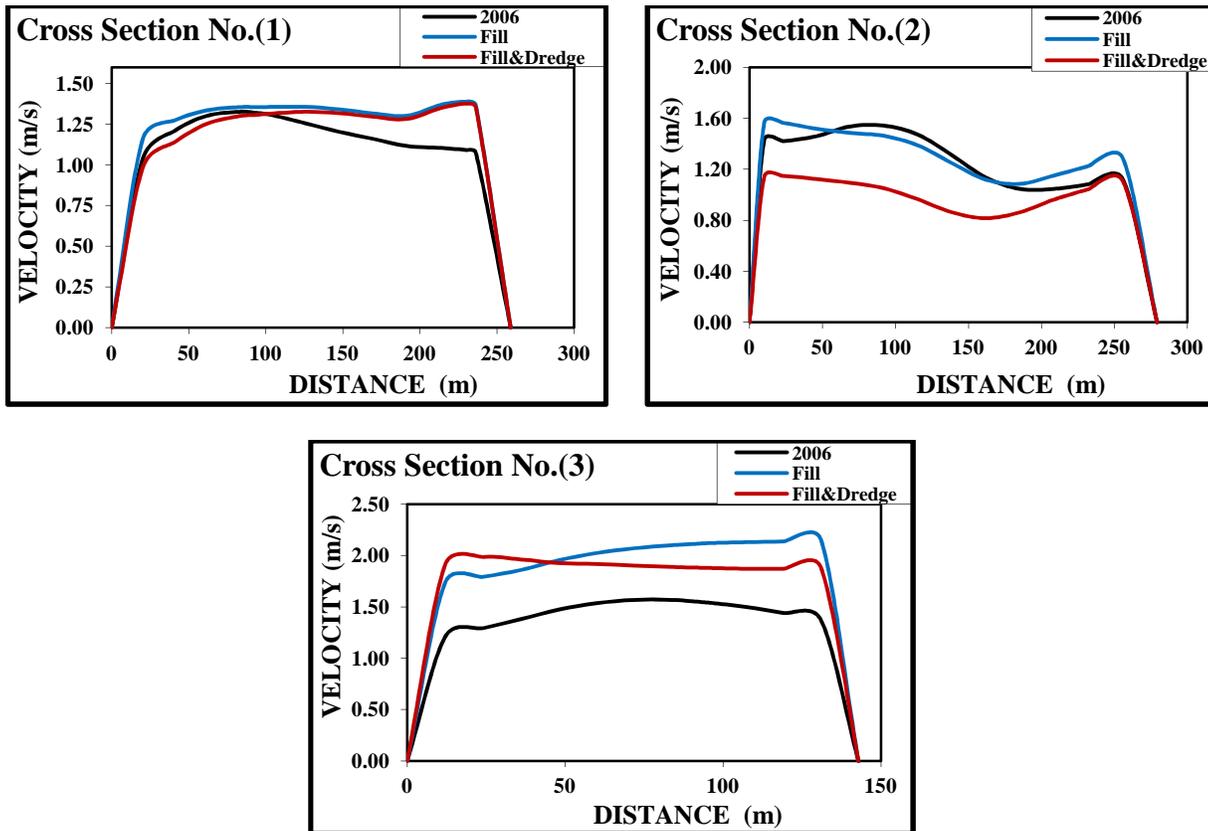
The velocity profiles at three cross sections along the reach for alternative 2 were presented in Fig. (18) for the case of emergency flow compared to the basic case. The figure showed that the results of velocity profiles were redistributed along the cross sections to be more regular than the basic case at cross section No.1. It was declared that the velocity values were increased at cross section No.3 and decreased at cross section No. 2 compared to the basic case. That was resulted in the effective part of these sections were filled and dredged respectively.

Fig.18. Velocity Profiles for the Basic, Alternatives (1) and (2) at Emergency Flow

The model was run at emergency discharge with its corresponding water levels. The discharge was $2546.30\text{m}^3/\text{s}$ and its corresponding water level was $+5.90\text{ m}$ MSL. The resulted velocities recorded in this case are ranged between 0.80 and 2.00 m/sec in the outer curve. While the average velocities along the reach were around 1.40 m/s .
