## **SCOUR EVALUATION FOR THE NILE RIVER BENDS ON ROSETTA BRANCH**

### **ABSTRACT**

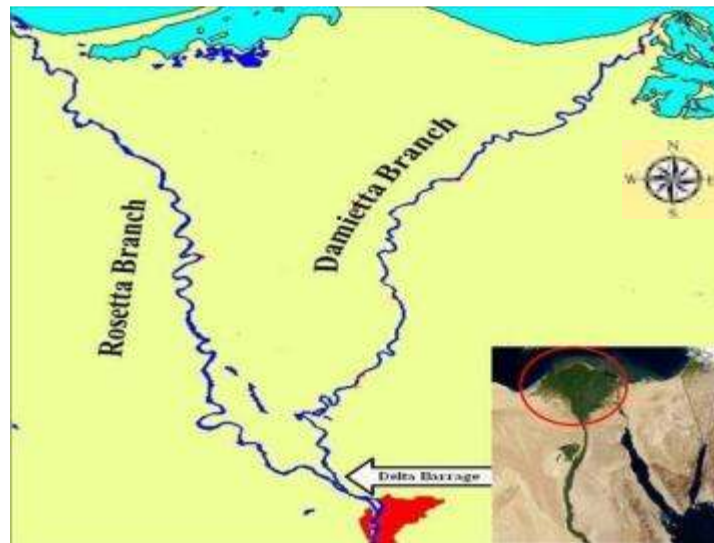
**Fig. 1. Schematic Sketch for Rosetta and Damietta Branches**

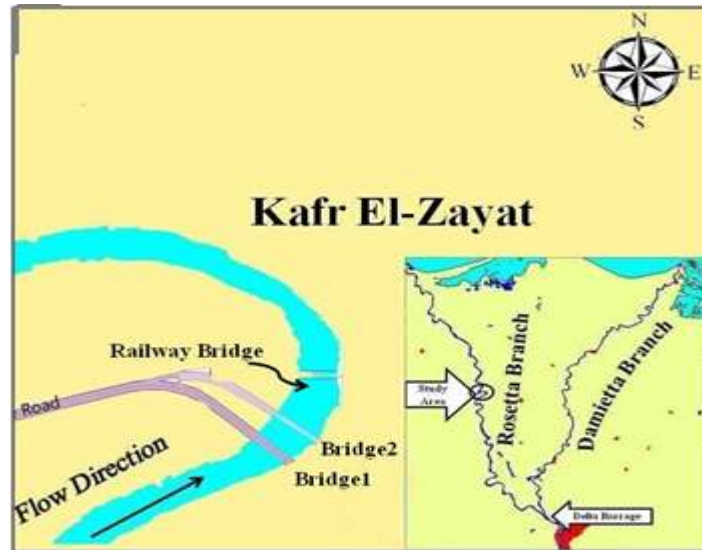
Kafr El-Zayat City is located at the outer curve of a very sharp bend at Km 123 of Rosetta Branch. The study area was 3.5km long, located downstream of Delta Barrage from km 145.00 to km 148.50 downstream of El-Roda Gauge Station. The study area is a bend consisting two highway bridges and one railway bridge were located. Figure (2) and Table (1) showed the geometry and location of the 13 bridge piers and their distance from the left bank. It should be denoted that the coordinates of the study area were (289181.00 m E, 3410603.00 m N), and (287432.08 m E, 3413467.01 m N) UTM

Fig.2. Schematic Sketch for the Study Reach

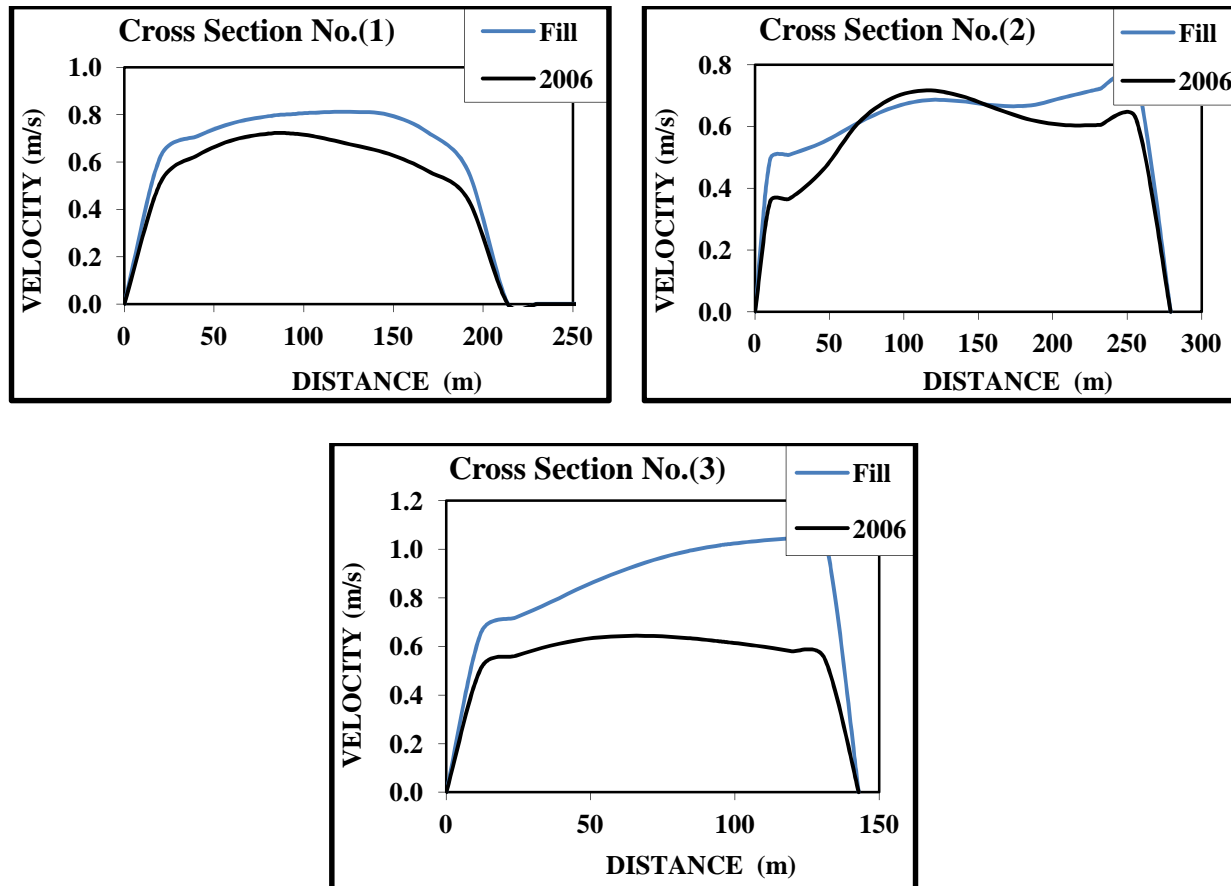
In case of Maximum flow, the discharge was  $809.03\text{m}^3/\text{s}$  and its corresponding water level was  $+2.60\text{m}$  MSL. The predicted velocities were ranged from  $0.45$  to  $1.05\text{m}/\text{sec}$  in the outer curve for different cross sections. However, the average velocities of the reach were around  $0.70\text{ m/s}$ .

The velocity profiles of alternative (1) compared to the basic case at different cross sections were presented in Fig. (13). The same curves trend was found. Moreover, it was declared that the velocity values were higher than the basic case resulted in decreasing the cross sectional area after filling.

Fig.13. Velocity Profiles for the Basic Case and Alternative (1) for the Max. Flow
